# Manhole Inspection Summary

Manhole # S37E\_\_057MH

Insp Date: **10/20/08 1:41 PM**

**Location** Address: **10 holliday st**

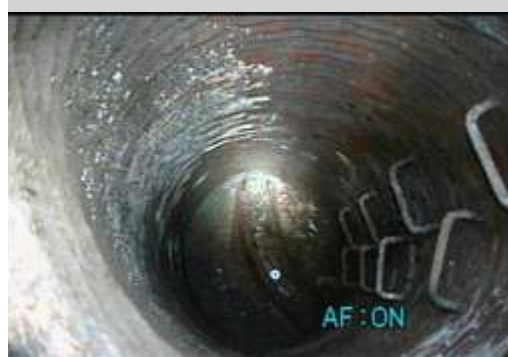
Top View

Condition: ☐ Sound ☒ **Cracked** ☐ Root Intrusion ☐ Loose Brick ☒ **Deteriorated**

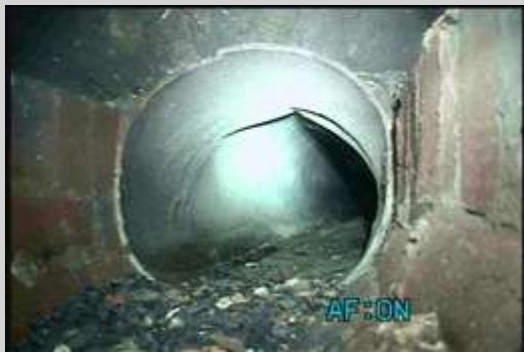
12 O'Clock Outflow

10 in. Circular Gravity Sewer  
Pipe Out @ 12 O'Clock

Infiltration: **None** Pipe Seal Cond: **Unknown**

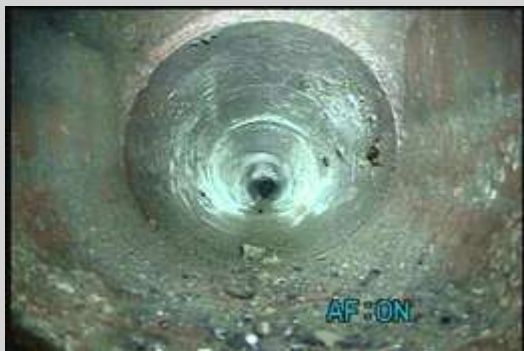
4 O'Clock Inflow

10 in. Circular Gravity Sewer  
Pipe In @ 4 O'Clock

Infiltration: **None** Pipe Seal Cond: **Unknown**
